SANTA FE INTERURBAN

A 2014 exercise in train trashing

By Jerry Hansz

Part II

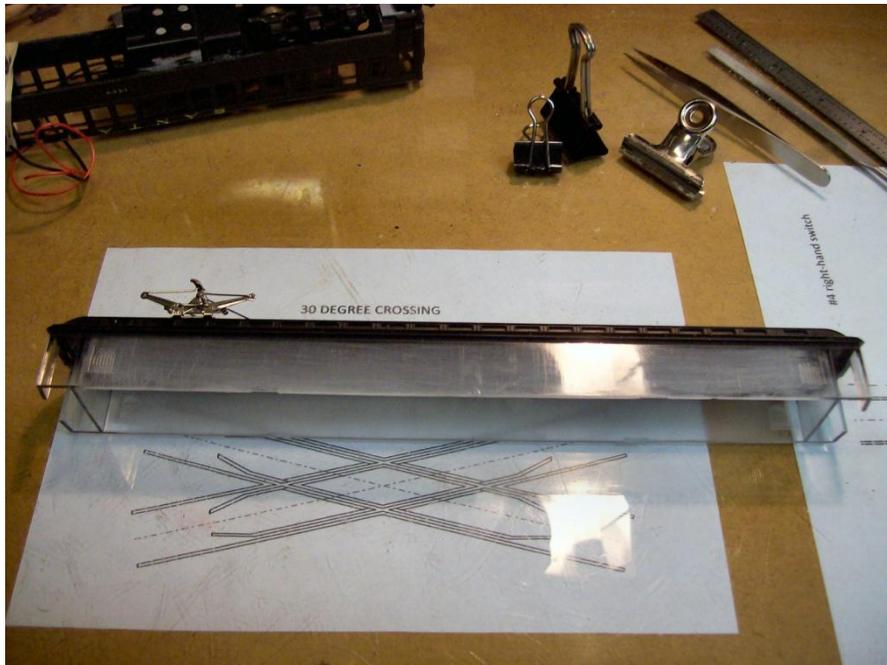
The clear window portion of the roof shell was scarred, probably by glue. Attempts to remove the scarring didn't work, so I 'frosted' it with emery cloth. (I had planned to make some sort of overlay with passenger outlines anyway.) The mounting tabs on the bottom of the roof shell were removed and the area was smoothed.

Windows 'frosted'

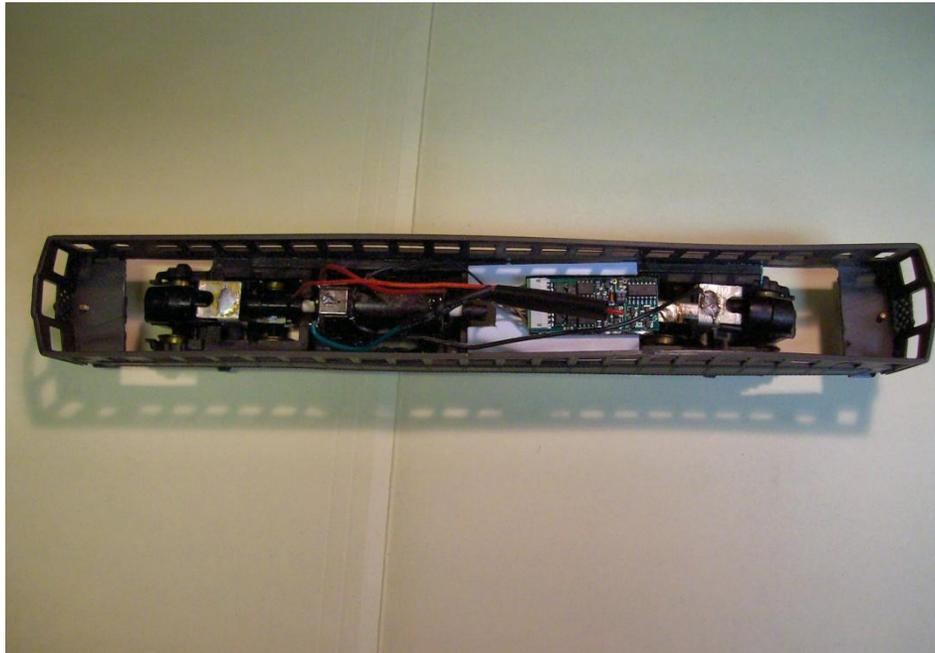
NCE D13SR decoder installed

I installed the NCE D13SR decoder on the center insert with double-sided tape. Wires were soldered and protected with shrink tubing.

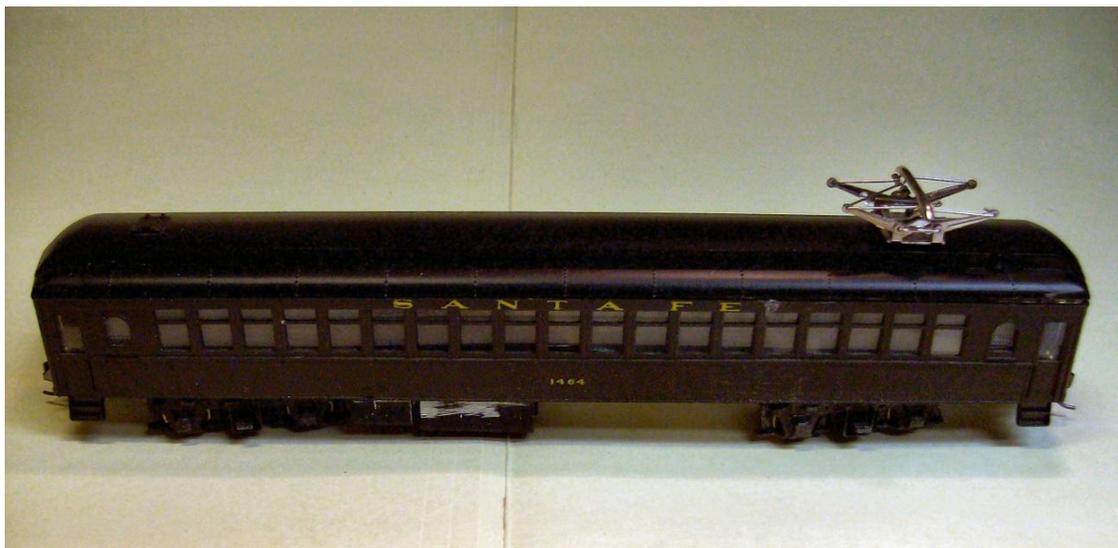
Assembled car

The car was placed on the programming track. It responded to the address 1464. NCE is 011, version 036. When placed on the main line it didn't run! Inspection showed that the front truck had moved off the mounting pin, which caused the shaft to slip out of contact. Apparently the worm gear cover doesn't fit tightly enough to keep the truck in place. Back to the drawing board! The unit does look nice though. When I get some black brush paint, I'll touch up the undercarriage. Also will need some kind of headlight housing! I may add wires to get pickup from both sides of both trucks.

I disassembled the front truck. With the worm gear removed, the truck wouldn't move! The can motor draws so little current that the jam wasn't apparent. I removed the bottom cover on the truck and found a small solder chunk in the gears. After removing the obstruction, I greased the gears and reassembled the truck and installed it in the frame. The truck now stays on the mounting pin. The jammed gears apparently caused it to come off the pin. The car now runs, although slow at maximum DCC setting. Again, using old tired parts gets poor results!
